# **Southwest Museum** Rehabilitation Study Phase I Planning

# Southwest Museum Rehabilitation Study

Phase I Planning

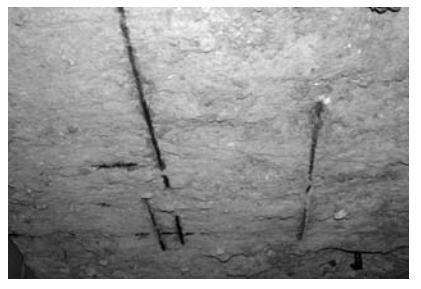
The historic buildings of the Southwest Museum Campus were found to be fairly sound. Exceptions are insufficient shear wall or other lateral load resistance in the east and south walls at the base of Caracol Tower and rusted reinforcing bars observed in the underside of the Museum Store slab.

**Soo1** - Rusted reinforcing bars below museum store

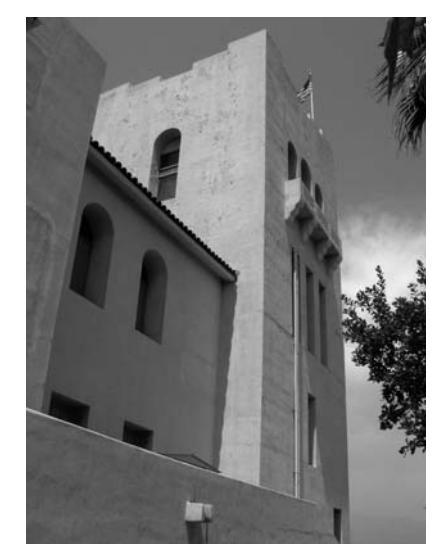
Soo2 - Main museum & Caracol Tower: South Facade

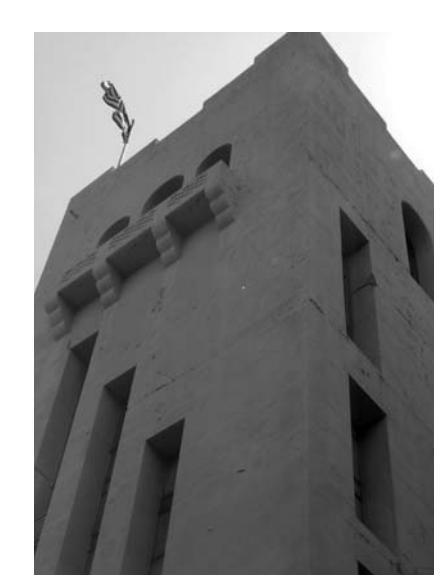
Soo3 - Caracol Tower - East façade

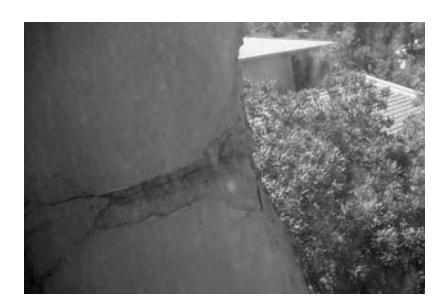
Soo4 - Caracol Tower - crack at window jamb

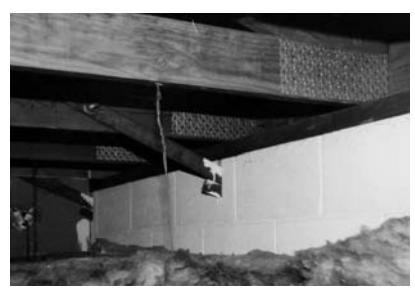
In the Braun Library, the positive wall anchorage between the walls and roof framing was found inadequate.

Soo5 - Braun Library - Connection of roofing diaphragm to wall

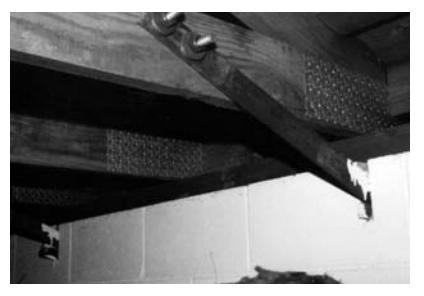
Soo6 - Braun Library: roof connection detail

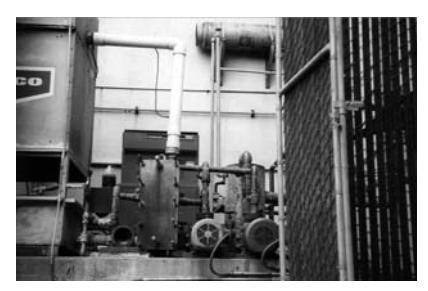
**Moo1** - Main building mechanical equipment south of Caracol Tower

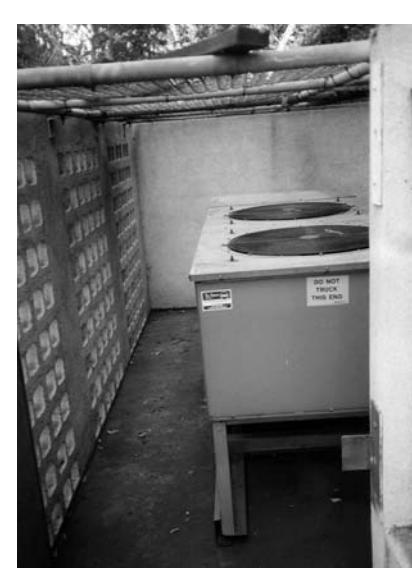
Moo6 - Condensing unit serving Braun Library

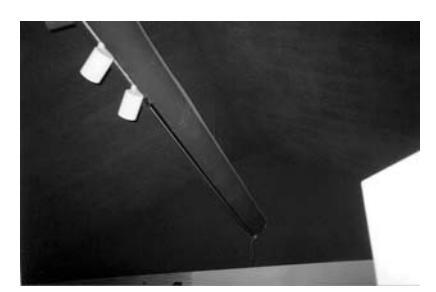
Moo7 - Exposed ducts in upper Poole Wing

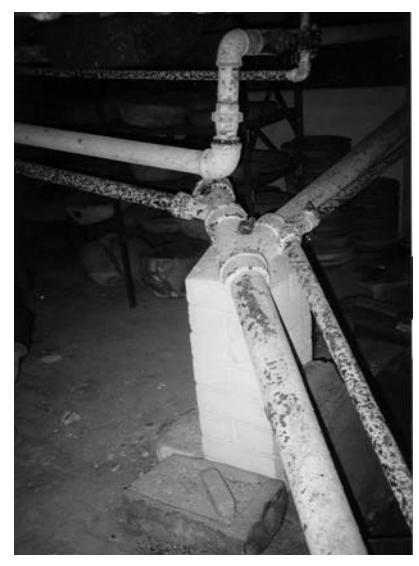
The domestic water piping is galvanized steel. Corrosion has occurred and it is recommended to re-pipe the building with copper. Problems with the site sewer lines have required several repairs.

Poo1 - Corroded galvanized steel water pipe

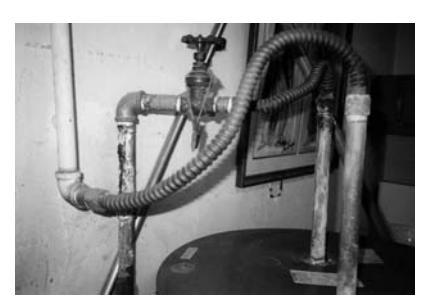
**Poo2** - Galvanized steel water pipe; signs of corrosion

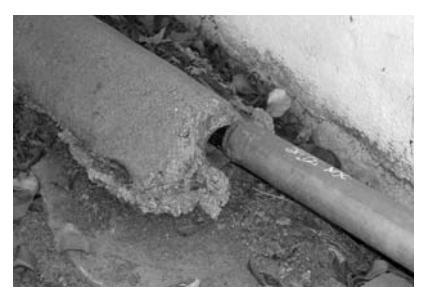
**Eoo4** - Exterior power conduit exposed to moisture

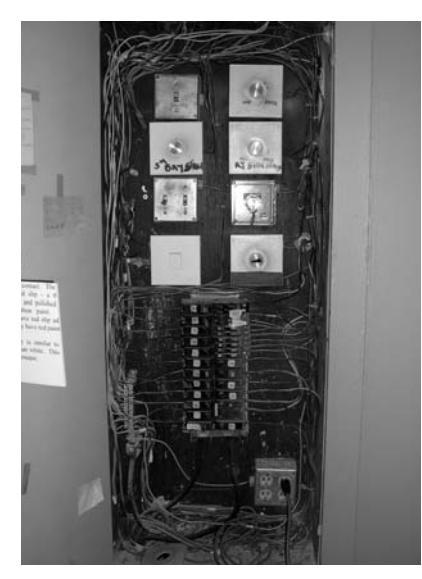
**E005** - Sprague Hall panel showing multiple code violations

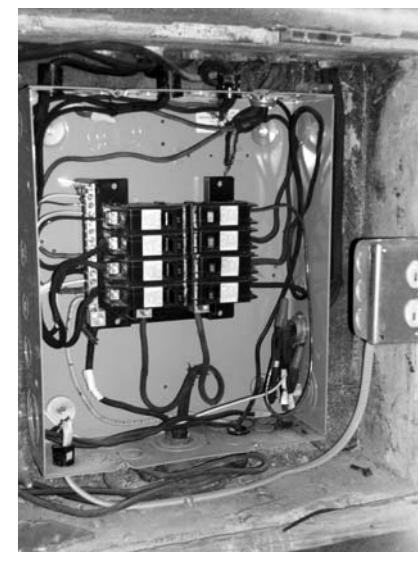
**E007** - Torrance Tower panel showing multiple code violations

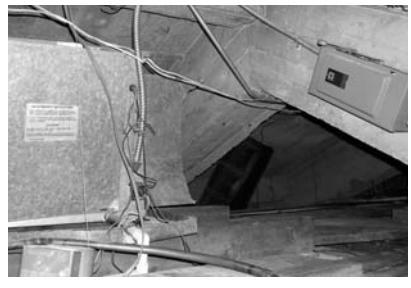
**Eoog** - Main Building attic, illegal wiring conditions

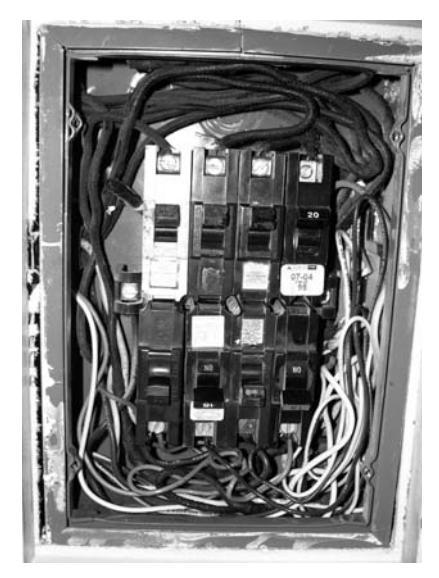
**E010** - Administration area panel showing multiple code violations

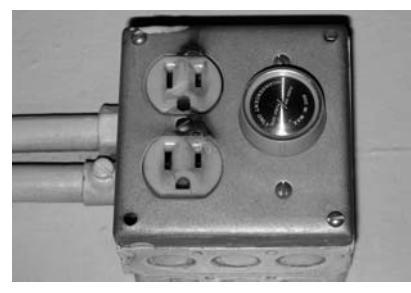
**E011** - Administration area; receptacle showing burn marks

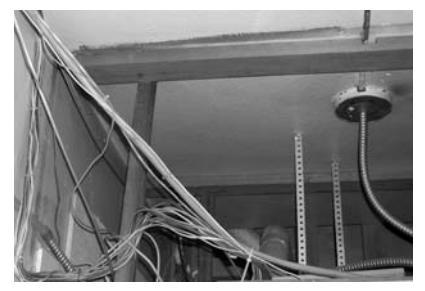
**E012** - Administration area; exposed, illegal wiring condition

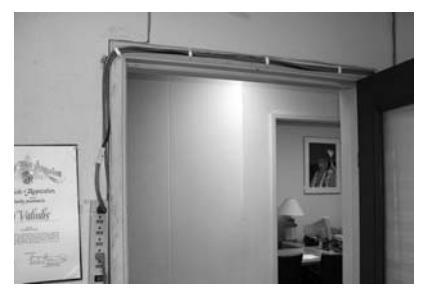
**E013** - Administration area; extension cord used for permanent wiring

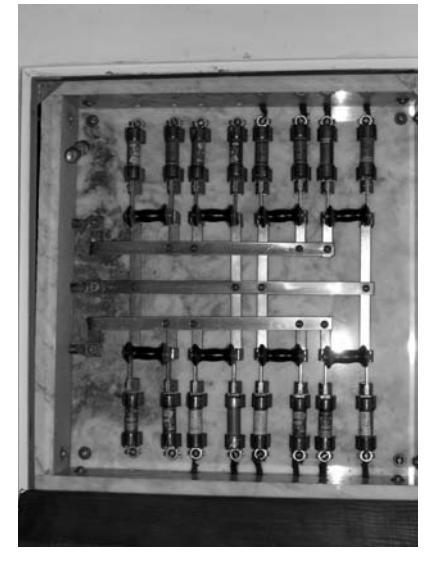
**E014** - Caracol Tower marble panel showing multiple code violations

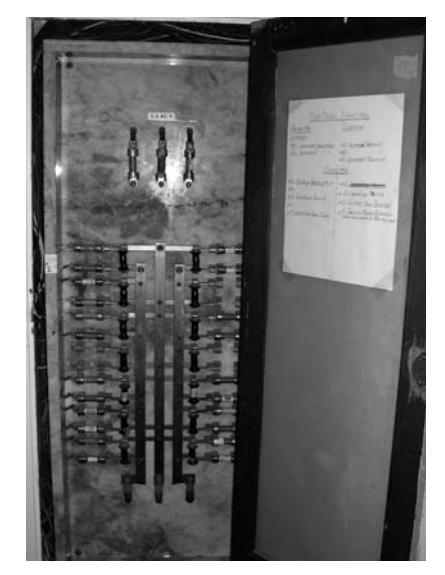
**E016** - Plains Hall- marble panel showing multiple code violations

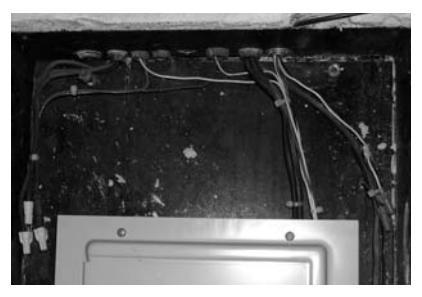
**E017** - Upper Southwest Hall panel showing multiple code violations

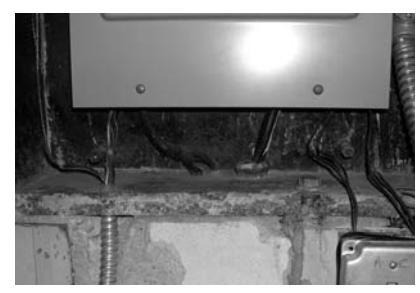
**E018** - Bottom of Upper Southwest Hall panel showing illegal switch in panel cavity

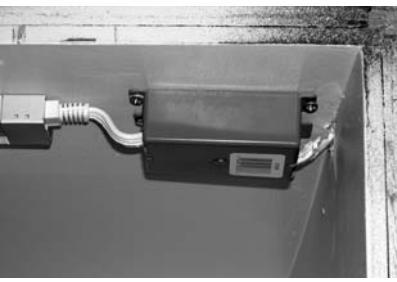
**E025** - Exposed junction box and Romex connectors in display case

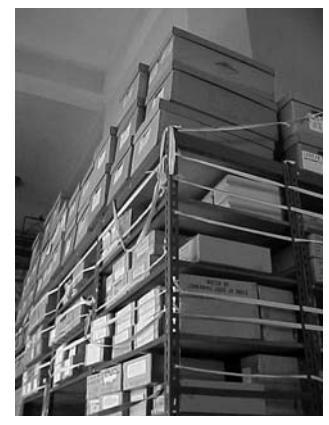
LSoo3 - High-piled storage in Caracol Tower

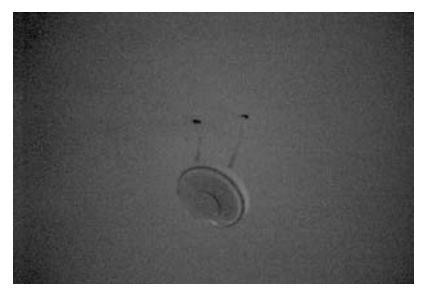
The project is provided with an outdated fire alarm system. Smoke detectors in several locations are improperly installed (*See Photo LS004*). SENSISCAN 1000 ADEMCO 694 EN Digital Communication by Fire-Lite Alarms Inc. (*See Photo LS005*) for a fire alarm system is provided at the main entrance on the second floor. The existing spacing and locations of smoke/heat detectors and manual pull stations are inadequate based on the current fire alarm design requirements. Furthermore, visual and audible alarm notification appliances were not observed during the site survey conducted.

LSoo4 - Improperly installed smoke detector
