# **Southwest Museum** Rehabilitation Study Phase I Planning

# Southwest Museum Rehabilitation Study

Phase I Planning

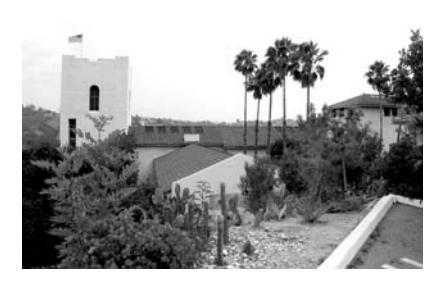
HR001 - View of museum from parking lot

Most visitors originally arrived at the Museum from an entrance on its south elevation, which served as the main entrance of the Museum until a parking lot was built north of the Museum in 1956. The entrance's original doorway and window opening are intact but its materials have been otherwise altered. (See photos HR001, HR002, and HR003)

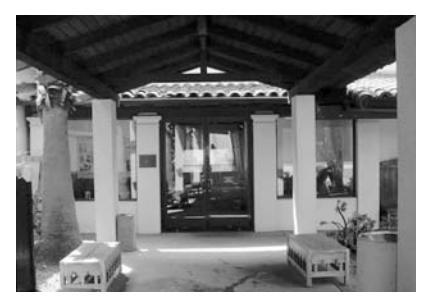
and portico were built within the period of significance of the Museum. Note that the original arch over the Hunt and Burns north entry was filled in at this time. Metal framed doors and windows were added during the 1977 alterations by Glen Cook, architect of the Braun Research Library. This alteration enclosed the entrance. The materials are not significant.

**HR003** - Upper entrance vestibule, added 1941, and walkway canopy c.1977

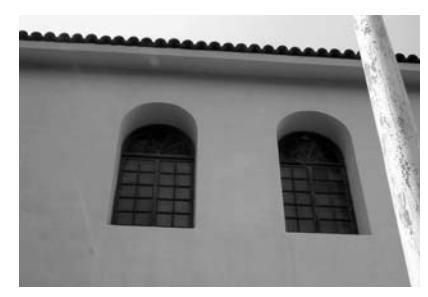
Many windows of the Main Building are original, although about half have been replaced. The original window materials consist of wood framed multilight casement windows with lunettes above each. Replacement windows are single-paned and set in aluminum frames. On the north elevation of the Main Building window materials were removed during an alteration in 1938, and the openings were filled in with concrete and coated with exterior finish. While many of the Main Building's window materials have been replaced, window openings on each elevation are significant. (*See photos HR004 and HR005*)

**HR004** - South elevation of main building; original windows at West End

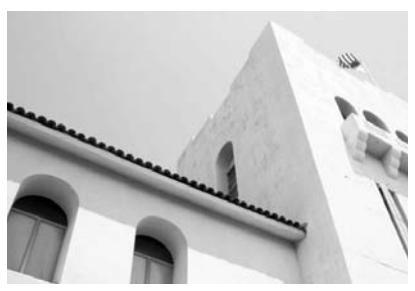
**HRoo5** - South elevation of main building; replacement windows at East End

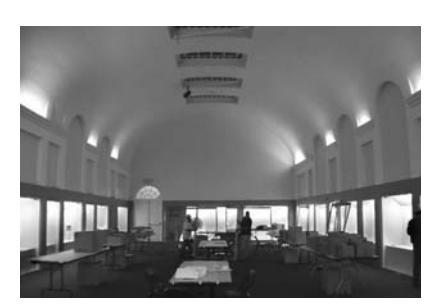
HR007 - Sprague Hall: current condition

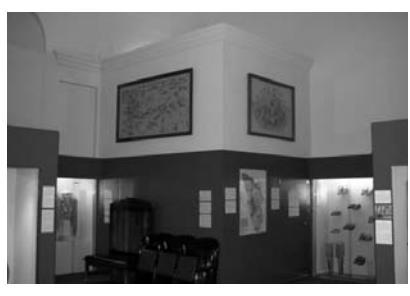
HRoo8 - Elevator machine room enclosure in Plains Hall

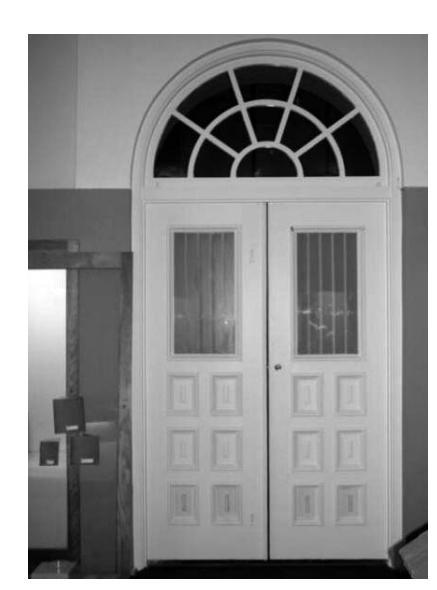
In Sprague Hall on the west elevation an original door and window opening to balcony exists and is significant, but the original materials have been replaced with materials that are not significant.All other doors, with lunettes above, both on the interior of Sprague Hall and Plains Hall as well as between the exhibit halls and the central entrance lobby are original, including their openings and materials. (See photos HR009 and HR010).

HRoog - Historic doorway from Torrance Tower into Sprague Hall

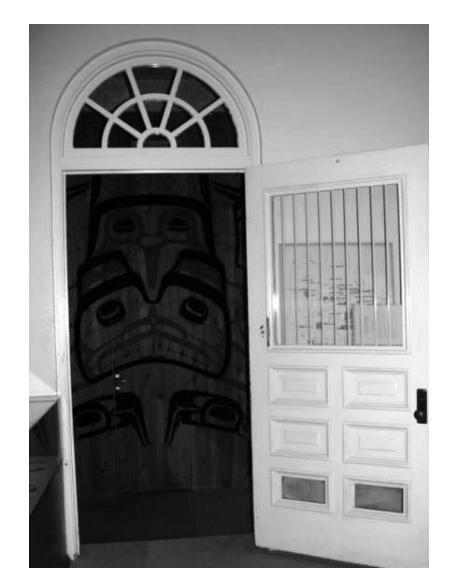
**HR010** - Historic doorway from Plains Hall to Northwest Hall

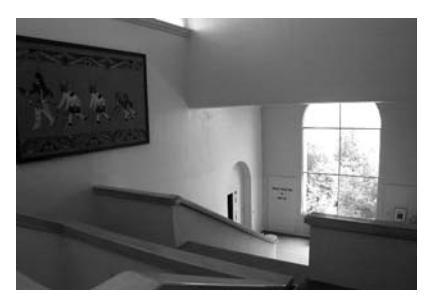
Connecting both upper exhibit halls to the main entrance of the Museum, the two-story Entrance Hall is a primary public space of the Museum consisting of a lower and upper lobby. Whereas minor alterations have occurred within this space, the original walls, ceiling, window and door openings, and light coves remain. Three lighting fixtures within this space are also original, their design and location having been chosen by Charles Lummis. The floor of the lower lobby has been carpeted, and the floor of the upper lobby has been covered in wood flooring, and yet the original flooring of both spaces may still be present underneath these alterations. A staircase leads from the lower lobby to the upper lobby, and while its finish has been altered and its steps carpeted it retains the significant character-defining features of its original construction and design. *(See photos HR011, HR012, and HR013).*

HR011 - Main stair (current condition)

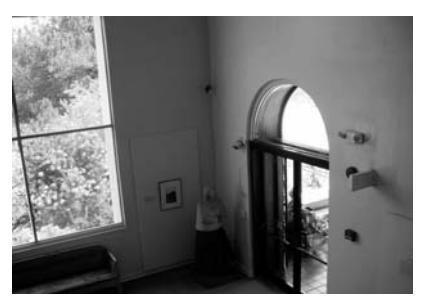
HR013 - Monumental window & door to terrace at lower lobby

The two-story window that dominates the south end of the entry hall was designed to introduce light into both levels. From the exterior, it is the focal point of the extended volume of the Entrance Hall that pushes out beyond the Main Museum and forms the visual center of the south façade. It is, therefore, a major character defining feature both within the entry hall and for the building as a whole. The window opening is original and significant, whereas the window materials have been replaced and are not significant.

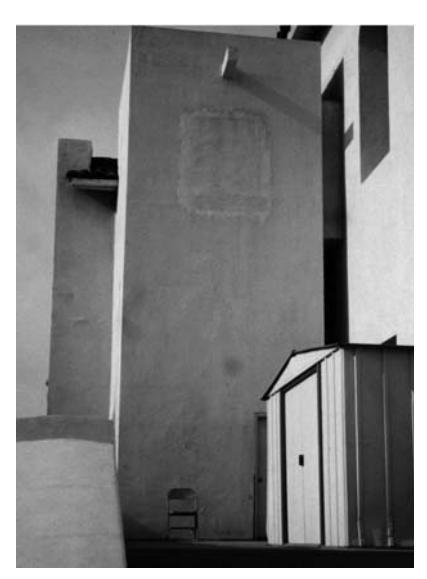
**HR016** - Elevator shaft tower; east side, showing filled-in window opening

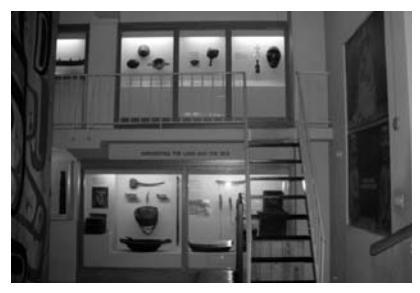
HR022 - Northwest Hall (Caracol 5)

The exhibit spaces of Caracol 4 and Caracol 5 have some similar characterdefining features. Both have original doorways leading to the Caracol stair, but the original door materials themselves have been replaced. The doorway and door materials leading into Caracol 5 from Plains Hall, however, are completely original, including the door hardware. Whereas the walls and ceilings of these exhibit spaces are original, excluding applied decoration, the exhibit cases and lighting have been replaced and are therefore not significant. The flooring of these exhibit spaces has been carpeted, and therefore is not significant. *(See photo HR022).*

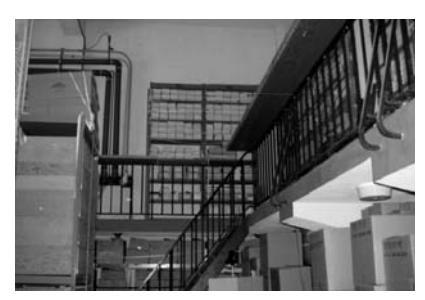
HR023 - Caracol 6; Mezzanine

Caracol 6 and Caracol 7 share similar features despite their different intended functions. Most notable are their mezzanines, which are similar to the mezzanine of Northwest Hall, but run around all four outer walls. In both mezzanines, a wood ledge has been added above the rails and is not significant. (See photos HR023 and HR024).

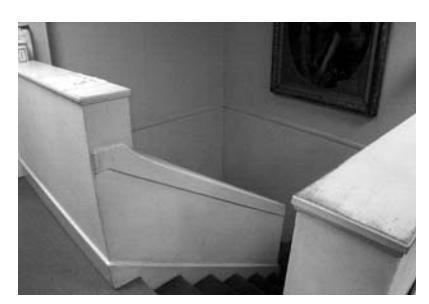
HR028 - Open stair from level one offices to basement

The basement of Torrance Tower is reached by a staircase that retains its original design and materials, other than its steps which have been carpeted. The walls of the stair are solid. The stair leads to a hallway, with a door at the opposite end, and before the door storage and office areas. At the base of the stair and under the stairs themselves, there is an office addition with hollow walls and a doorway. None of the materials of this addition are original. (See Photo HR028).

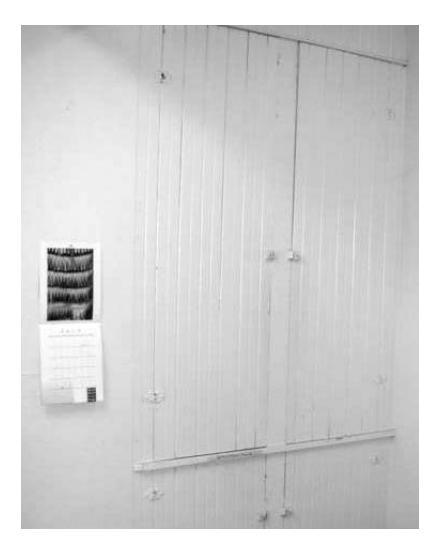
HR029 - Built-in cabinets in office area

On one side of the hallway is a storage area that retains no original features and therefore is not significant. On the other side of the hallway, two offices exist with historic door and window openings and materials, baseboards, and built-in wood cabinets. The windows are rectangular, wood framed, multi-light casement windows. The doors are paneled wood doors and have original hardware. The existing chair rail along portions of the wall of the southern-most office is original. The floors have been covered with resilient tiles but the original scored-concrete flooring may remain below. Parts of the baseboard have been covered with a flexible cove base material. (See photos HR029 and HR030).

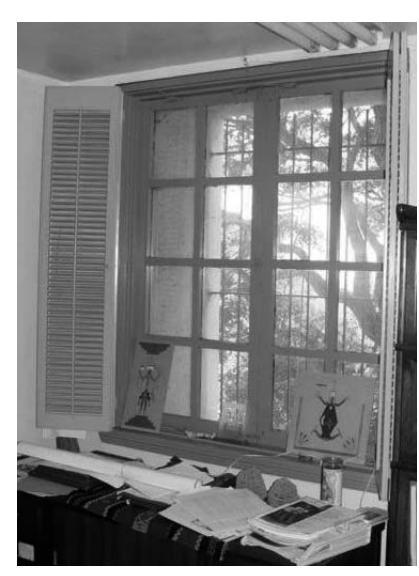
HR030 - Basement office; original window

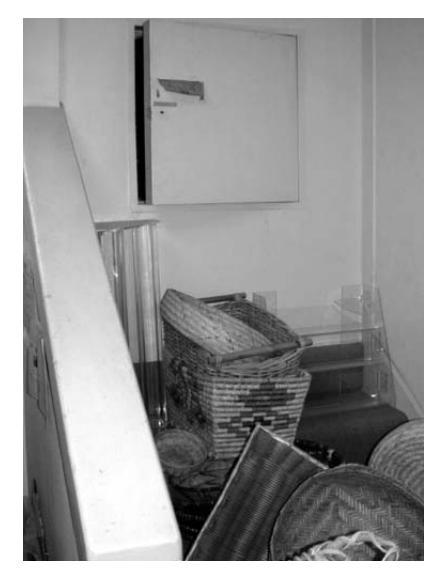
**HR032** - Office area; closed off stairway up into Torrance Tower

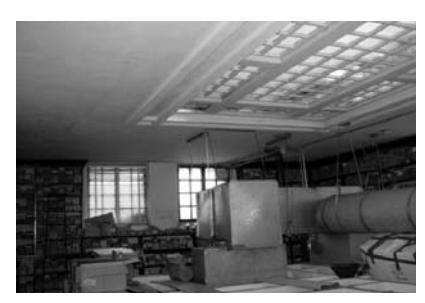
**HR035** - Torrance Tower: false skylight below; historic skylight above

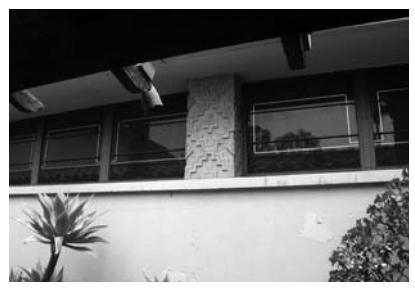
HR037 - Poole Wing: ornamental pilasters

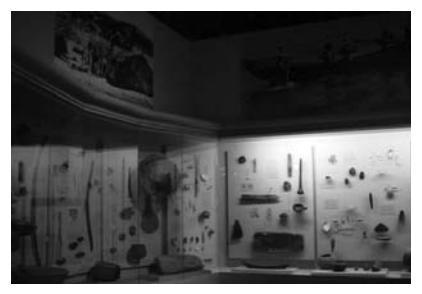
**HR038** - Poole Wing original display cases in California Hall

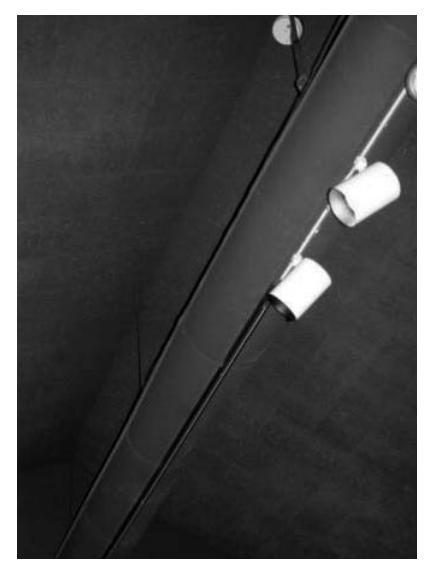
Originally, a continuous lighting trough ran north to south, suspended from the peak of the ceiling. It has since been replaced with an exposed HVAC duct with track-lighting mounted below. The acoustic ceiling panels, though indicated on Kaufman's drawings, may or may not be original, and therefore, significant.

**HR039** - Poole Wing: original ceiling with added lighting & duct

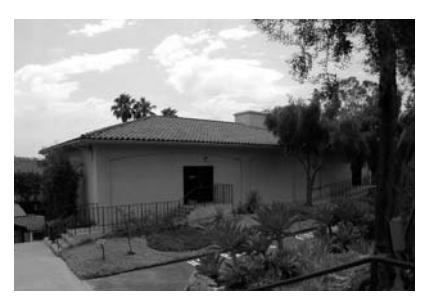
HR040 - Braun Research Library; north side

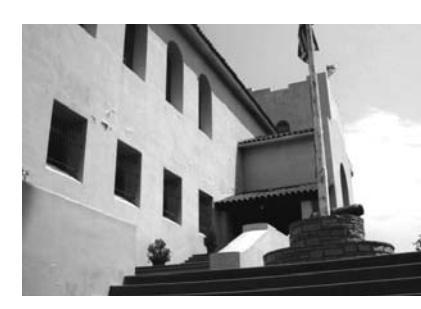
HR042 - Cannon & flagpole on south entry terrace

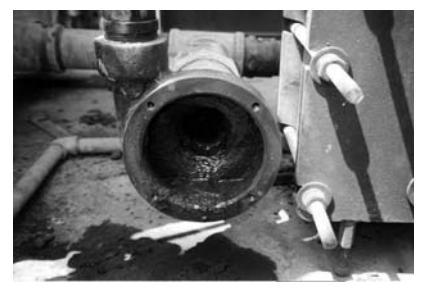
Moo2 - Back-up pump removed for service

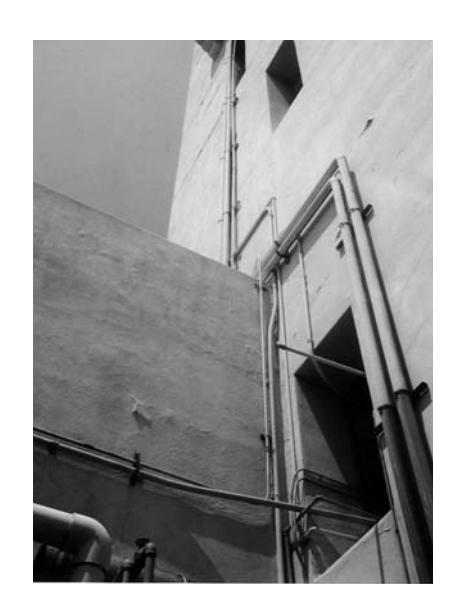
**Moo3** - Piping from condenser; south face of Caracol Tower

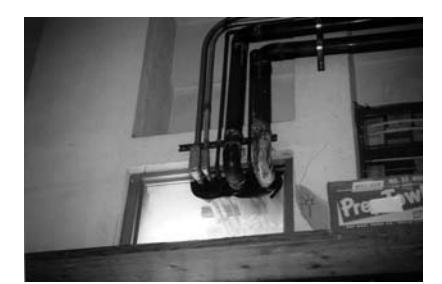
**Moo4** - Condenser piping enters Caracol Tower through window

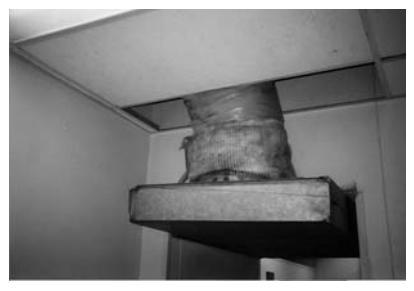
**Moo8** - Duct from Torrance Tower to museum level one

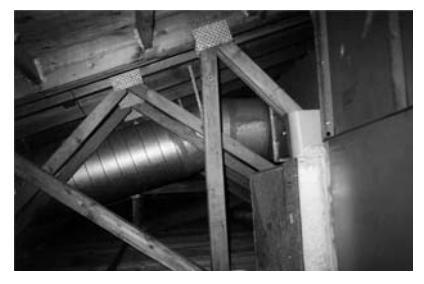
Moo9 - Uninsulated duct work in Braun Library

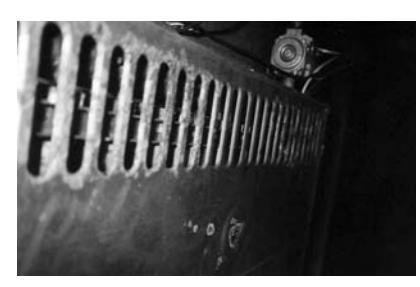
Mo10 - Duct furnace in Braun Library

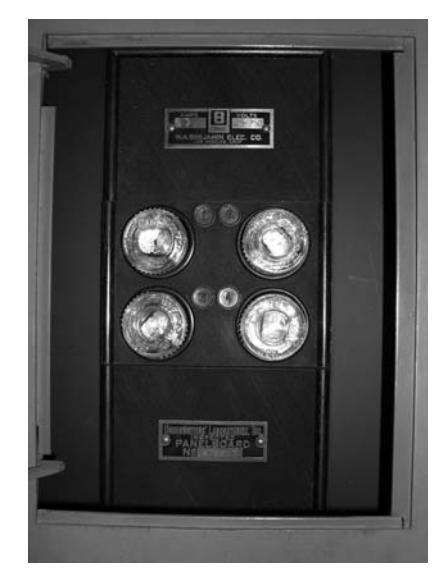
E002 - Boiler room fuse panel

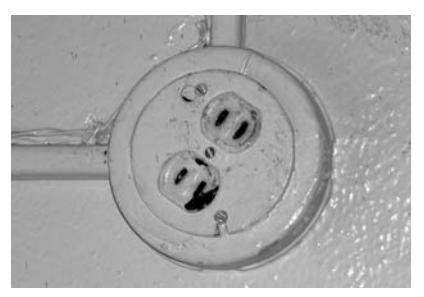
E003 - Ungrounded outlet, office area

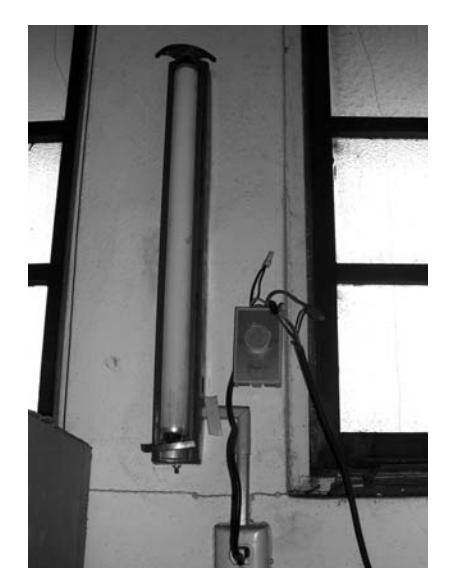
**Eoo8** - Torrance Tower, illegal wiring for exhaust fan

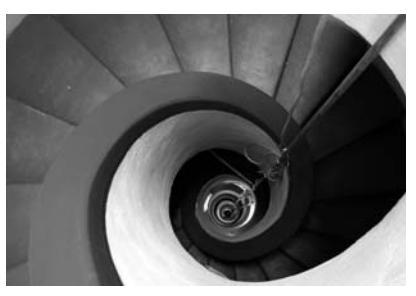
**E015 -** Caracol Tower stair - exposed, unsupported conduit

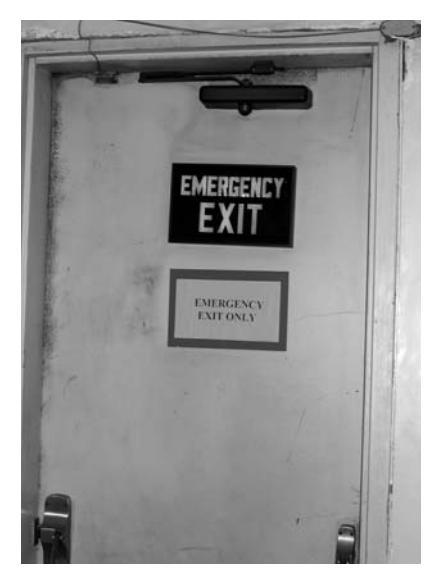
E019 - Administration area exit lacking proper illumination and signage.

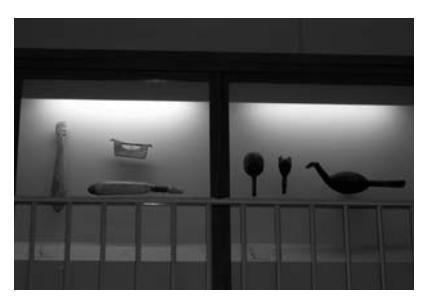
E020 - Inconsistent display case lighting typical throughout

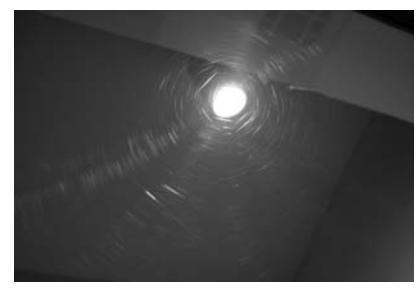
E021 - Unprotected bare display case lighting emitting UV rays; typical throughout

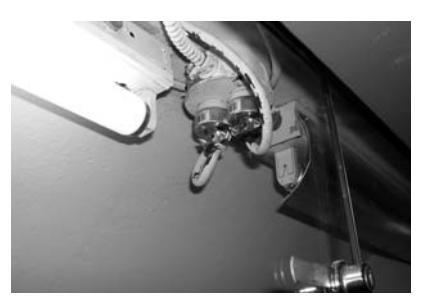
E022 - Inconsistent display case lighting typical throughout

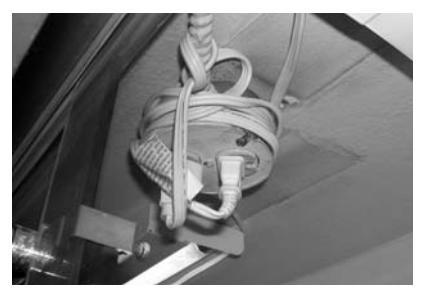
**E023** - Extension cord used for permanent wiring in display case

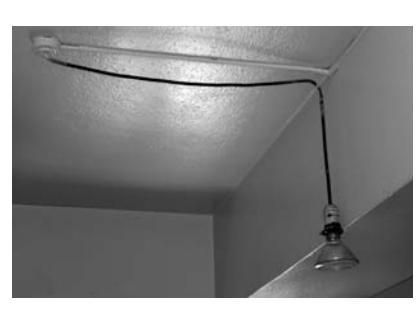
**Eo26** - Inefficient, out of date lighting in offices

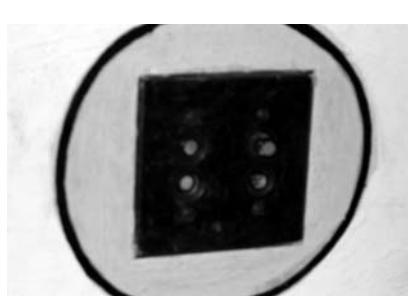
**E024** - Outdated push button switch in Caracol tower

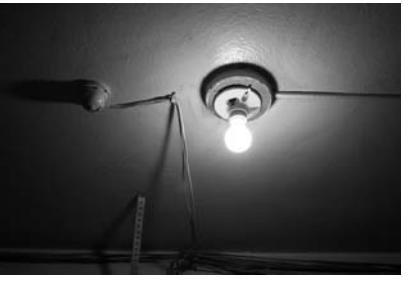
**E027** - Inefficient, out of date lighting in offices

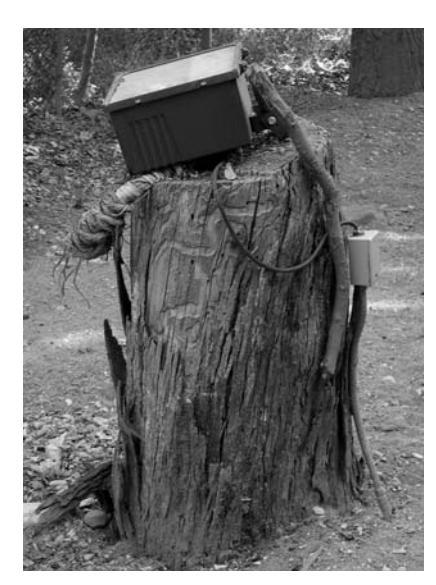
**E030** - De-activated exterior flood light at Caracol Tower

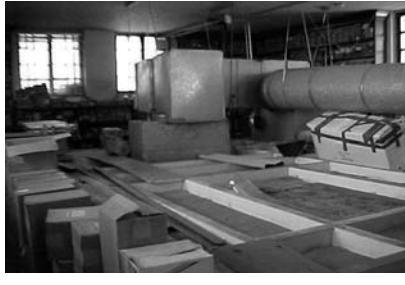
LSoo1 - Torrance Tower - Upper Mezzanine

The existing basement within the Torrance Tower, which currently contains office use, is provided with one means of egress only. Based on the current code, a minimum of two means of egress are required.
